# Miami Dade College parking garage collapse

# High Rise Concrete Overview

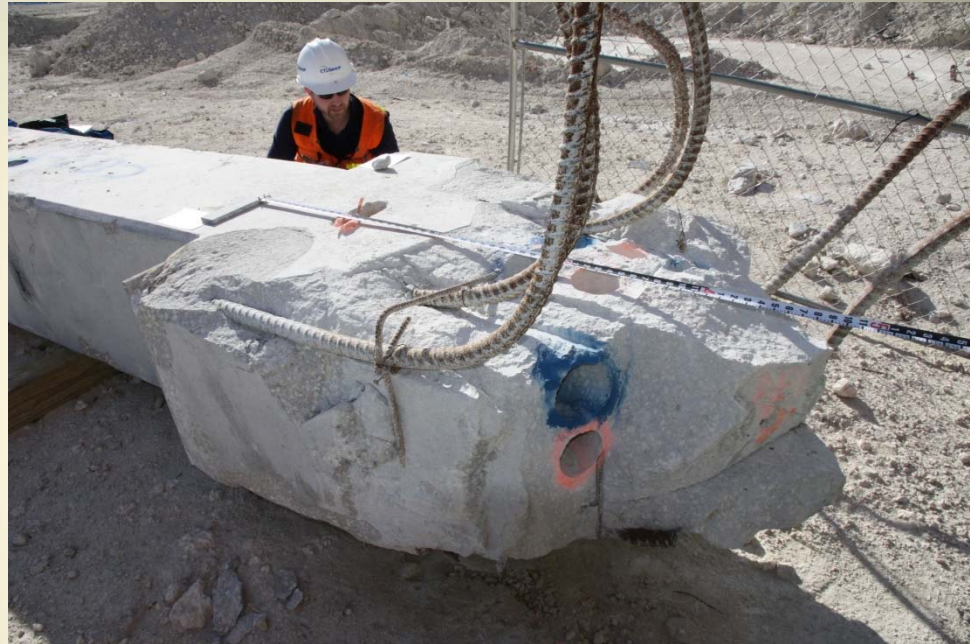
## Column B3

- Almost 5-feet of column base was missing
- Reinforcing was splayed out
- Specific shape to the failure surface

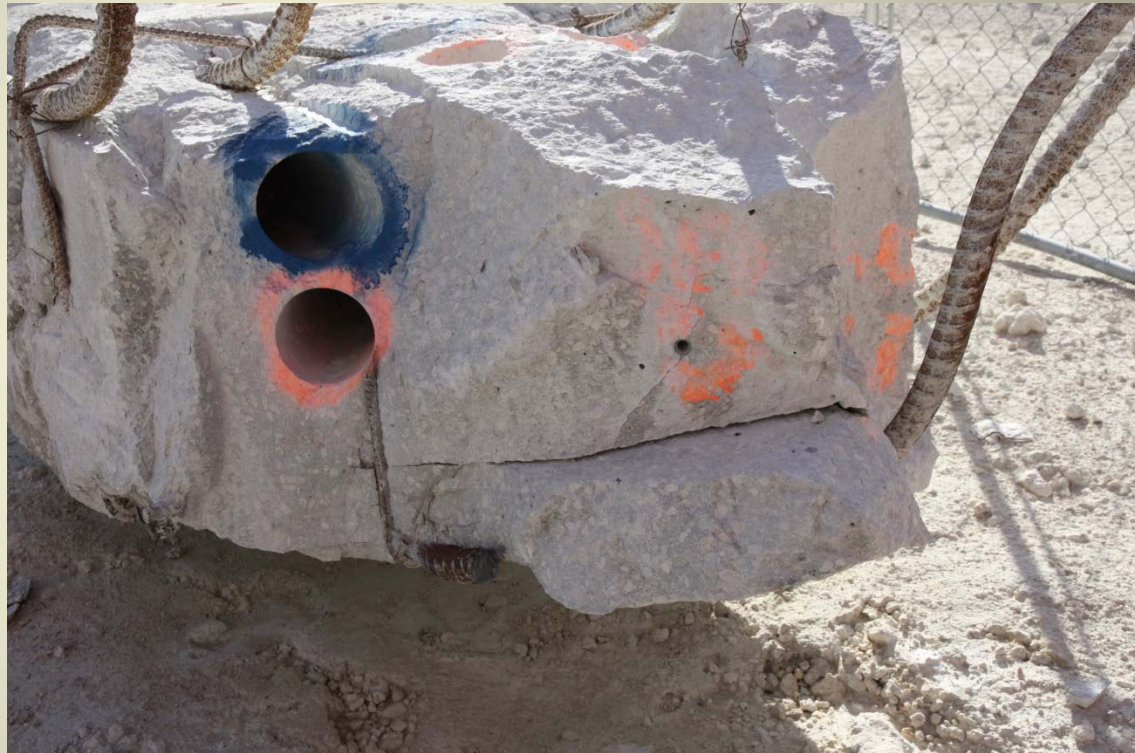
Column B3

- Specific shape to the failure surface

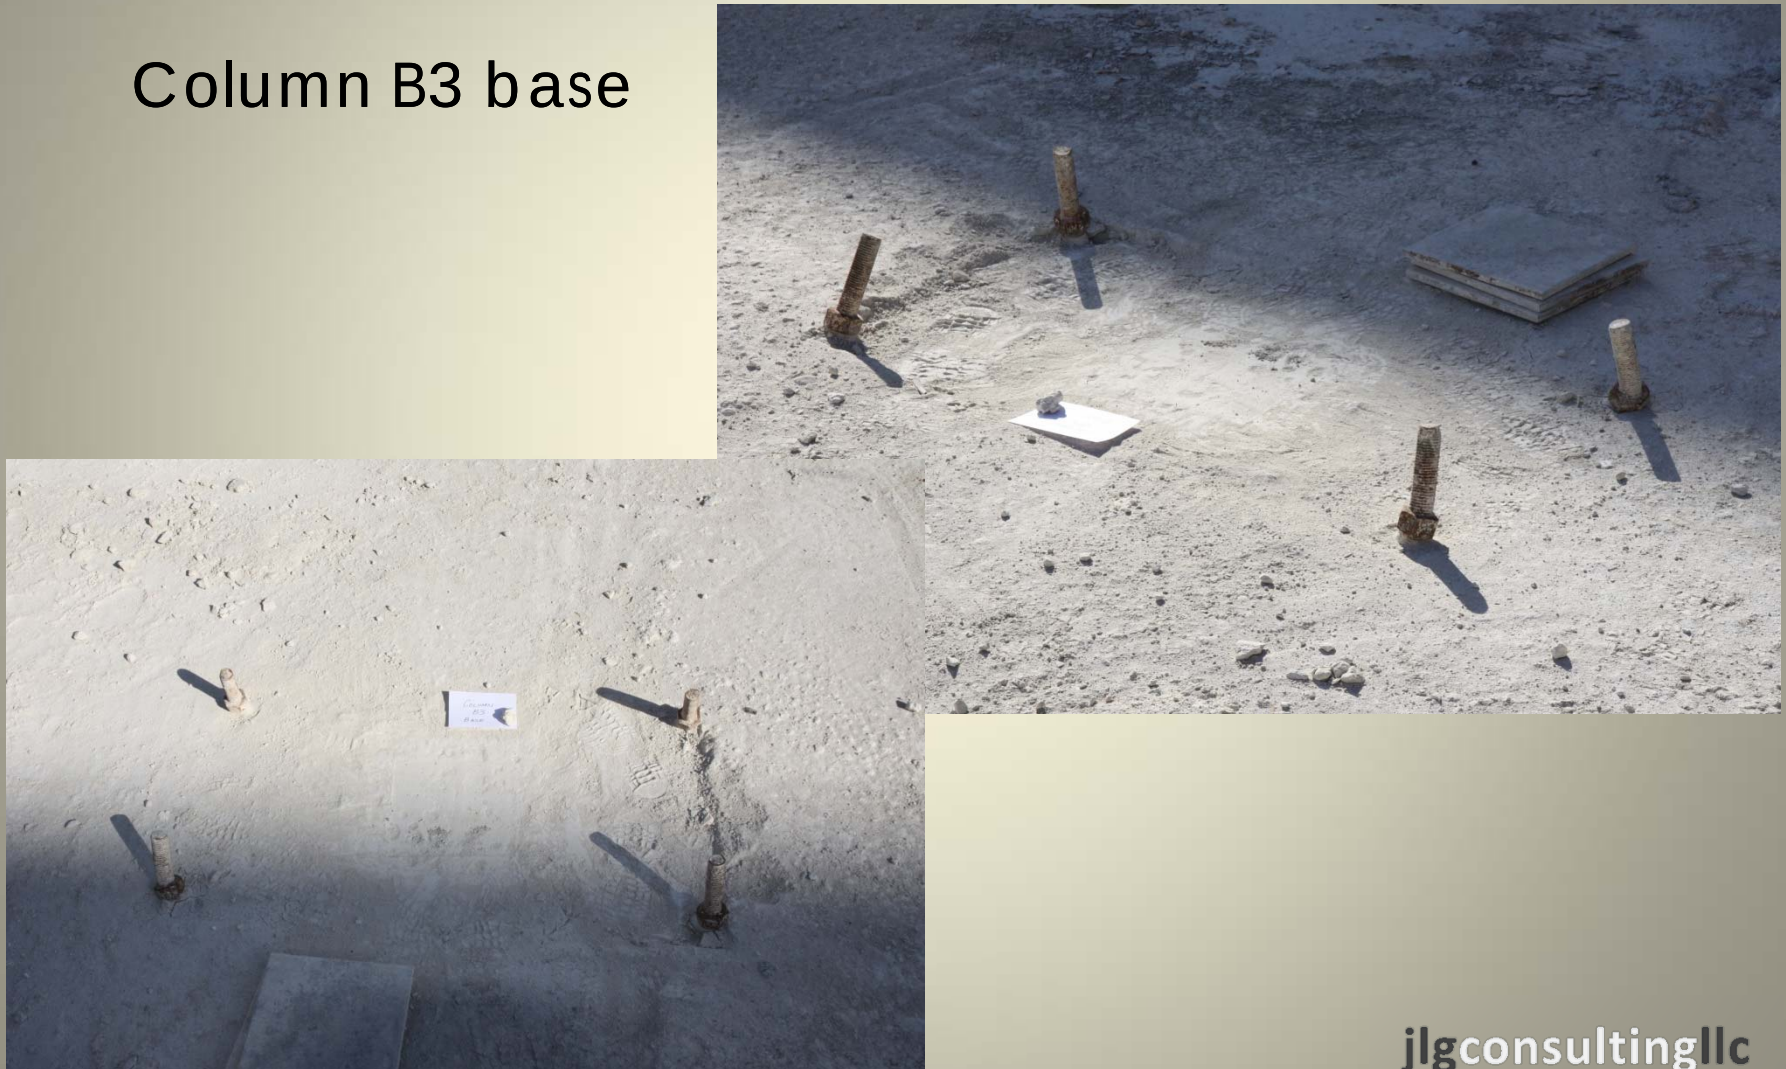
Column B3 base

Theory: Failure of Column B3 initiated collapse

- Facts:
  - No grout installed
  - Column rested on 8-inch square shims
  - Stress in column = 1.0 k.s.i.
  - Stress transferred to shims = 14.0 k.s.i.
  - Exceeds design  $f'_c$  by 5.0 k.s.i.
- Why didn't the failure occur sooner?

- Tested aggregate, cement, concrete:
  - Aggregate susceptible to creep
- Found micro-cracking of the concrete
  - Took time to form, coalesce
  - Failure planes perpendicular to major stress
- Confinement of column base by column ties
- Micro-cracking occurs until failure plane forms
  - Bottom 5-feet of Column B3 disappeared

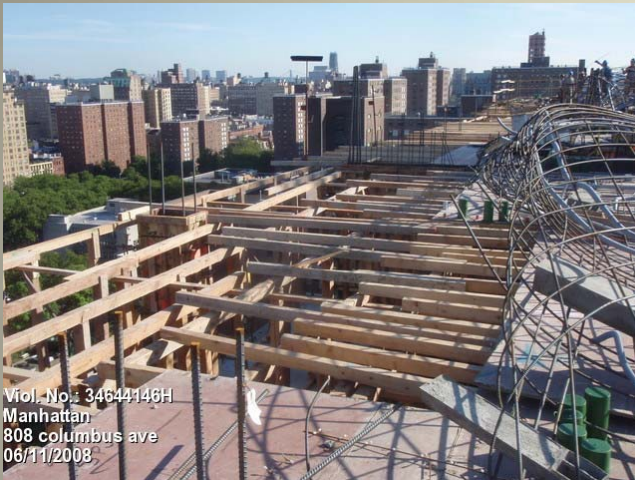
Formwork failures due to wind

Leading edge formwork failure:

- Reported winds of 30-40 mph
- 808 Columbus, Manhattan
- June 11, 2008

3. Incorporate national design standards for temporary construction
  - ASCE 37, Temporary Construction
  - ASCE 7, Wind load criteria
4. Require formwork construction to be positively secured against uplift
  - Perimeter decking
  - Provide positive load path to slab

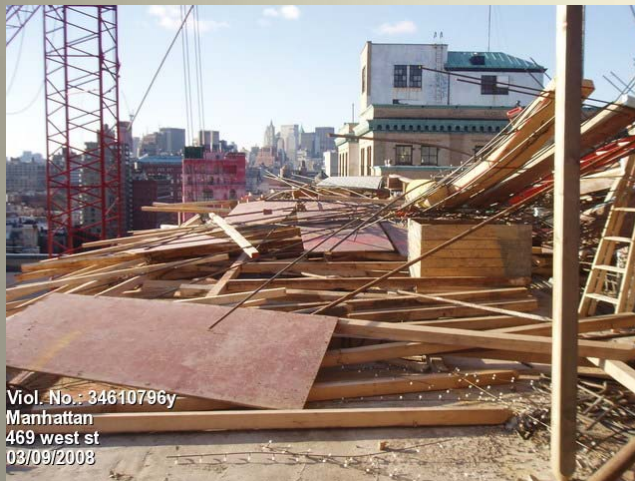
Leading edge formwork failure:

- Reported winds of 30-40 mph
- 469 West Street, Manhattan
- March 9, 2008

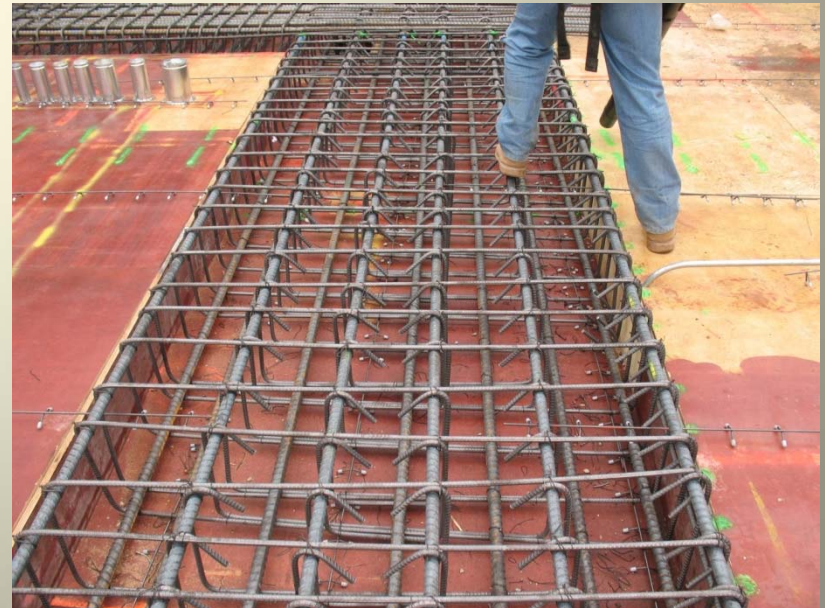
- 67 sets of stirrups required per design
- 47 sets installed
- Shear capacity reduced by ~20%

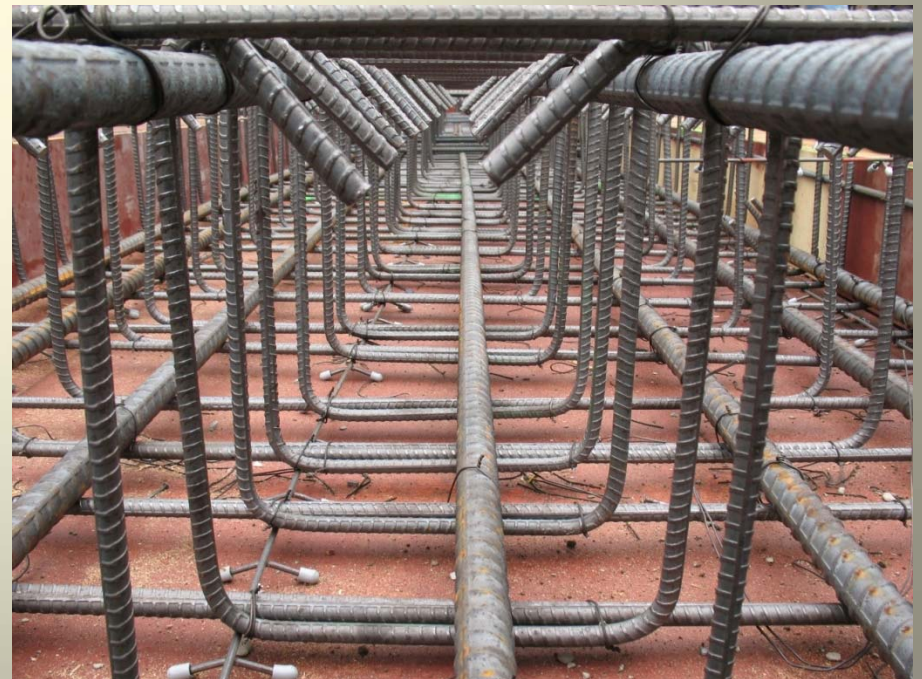
- Two of 6 stirrups legs engaged
- Shear capacity reduced by ~33%
