# Miami Dade College parking garage collapse

# High Rise Concrete Overview

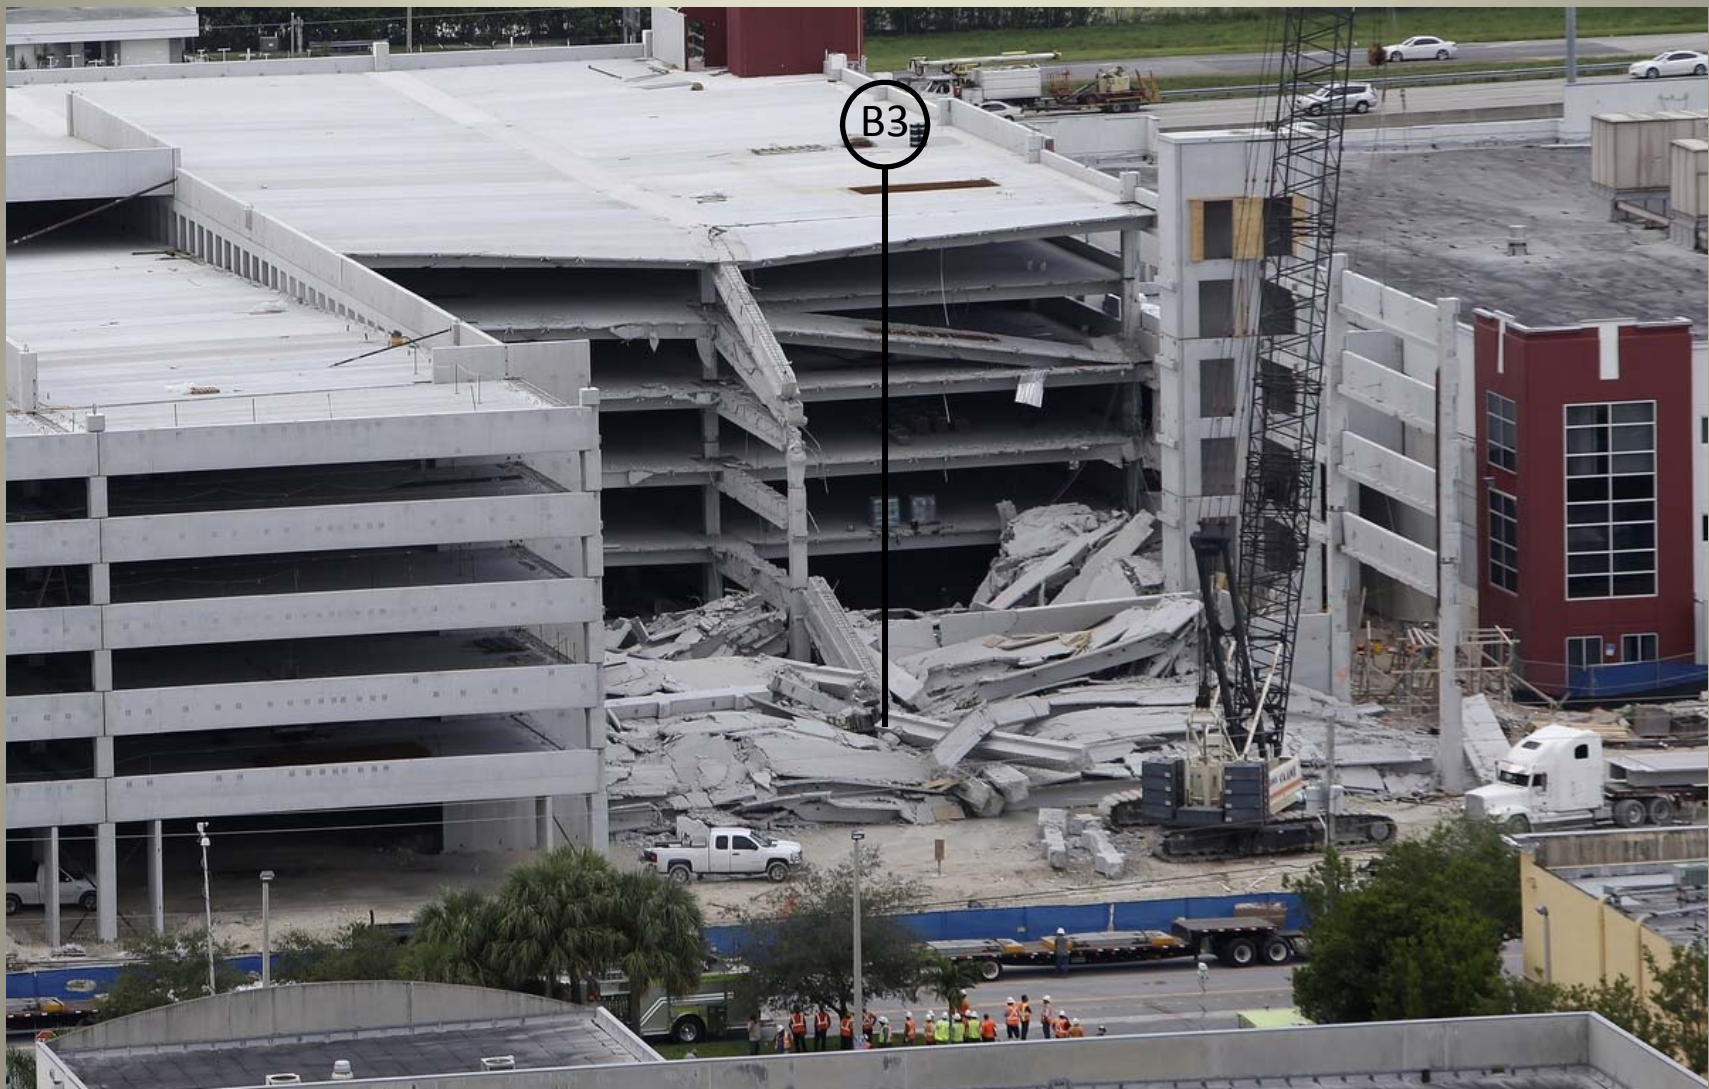
Theory: Failure of Column B3 initiated collapse

- Facts:
  - No grout installed
  - Column rested on 8-inch square shims
  - Stress in column = 1.0 k.s.i.
  - Stress transferred to shims = 14.0 k.s.i.
  - Exceeds design  $f'_c$  by 5.0 k.s.i.
- Why didn't the failure occur sooner?

- Tested aggregate, cement, concrete:
  - Aggregate susceptible to creep
- Found micro-cracking of the concrete
  - Took time to form, coalesce
  - Failure planes perpendicular to major stress
- Confinement of column base by column ties
- Micro-cracking occurs until failure plane forms
  - Bottom 5-feet of Column B3 disappeared

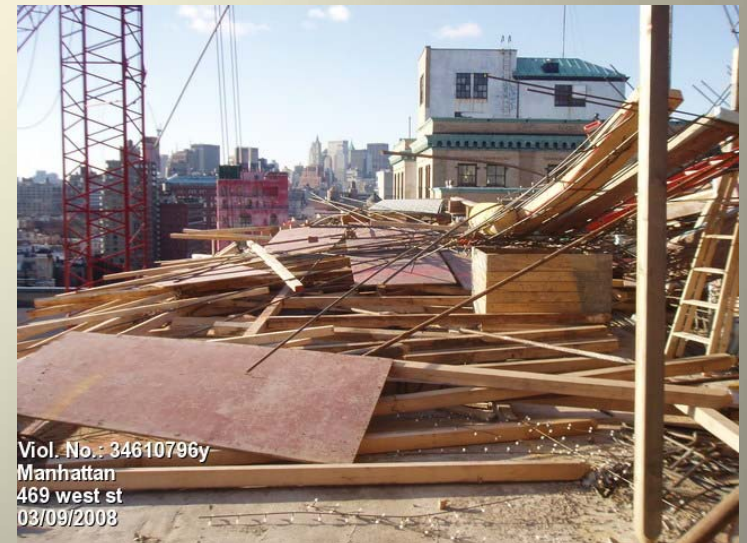
## High rise concrete formwork issues

- Observed inadequacies:
  - Incomplete design specifications
  - Improper installation and sequencing
  - Damage due to wind

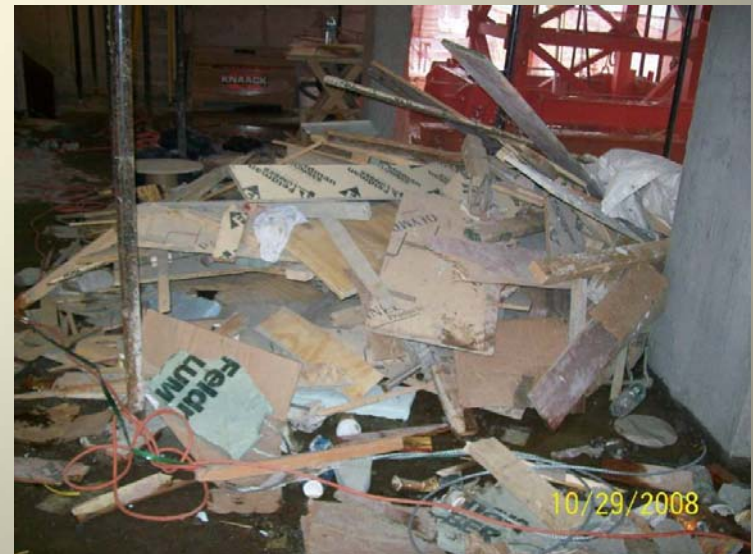
## Observed defects, violations

- Debris dangerous to public
- Poor housekeeping practices
- Impediment to emergency egress
- Improper material storage
- Fall protection
  - Missing
  - Inadequate

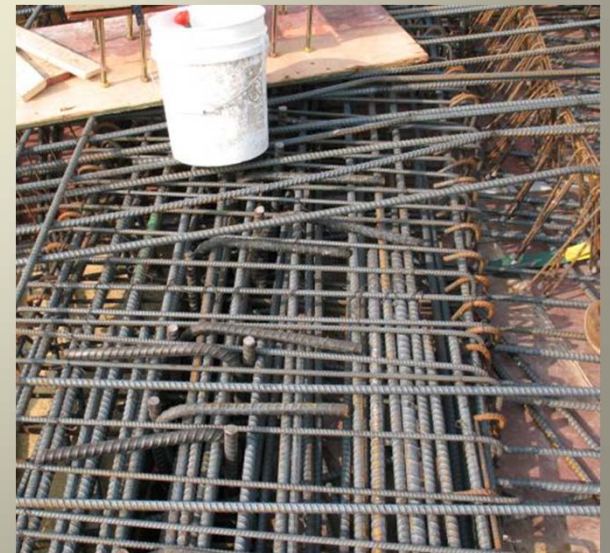
Special inspection and construction quality

- Observed defects
  - Ineffective special inspection
  - Insufficient level of documentation
  - Improper concrete testing
  - Misplaced reinforcing
  - Poor quality bar fabrication

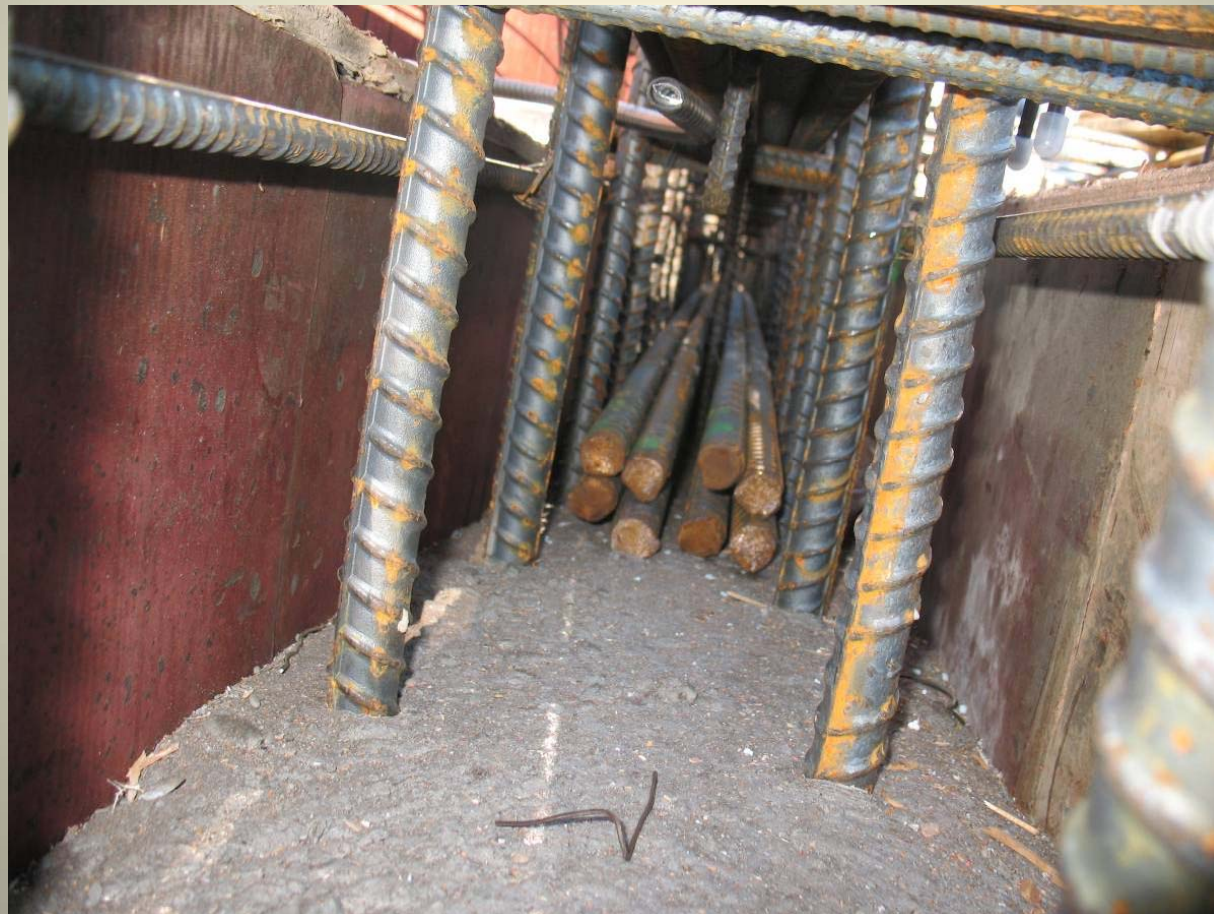
- Critical construction quality defects
  - Improper placement of shear reinforcement
  - Insufficient numbers of installed shear stirrups
  - Improper column tie installation
  - Improper bar engagement
  - Severe bar congestion
  - Improper column splice configurations

Special inspection and construction quality

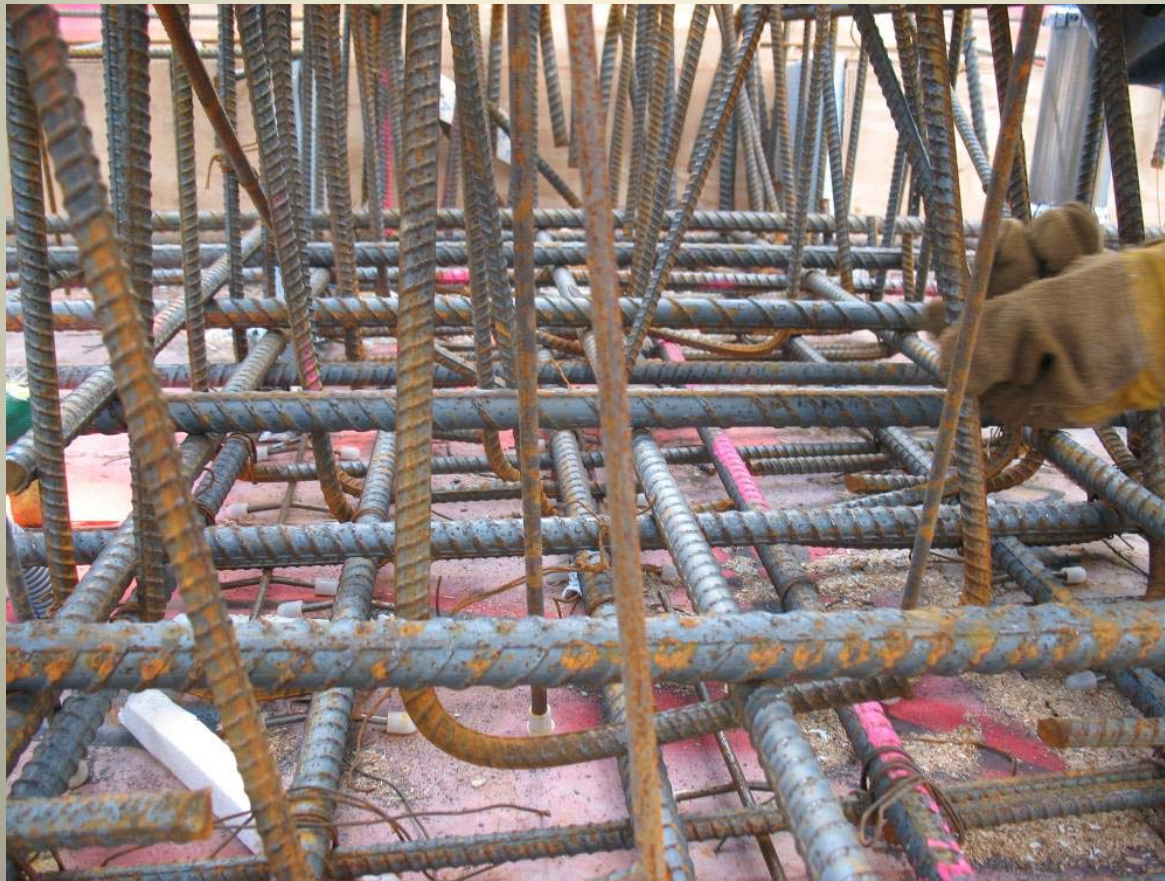
Special inspection and construction quality

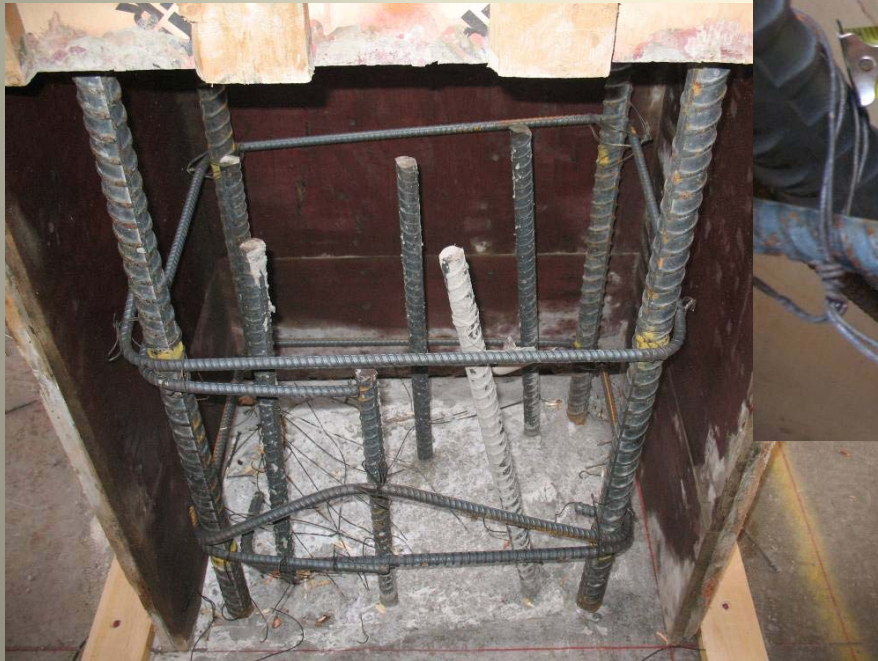
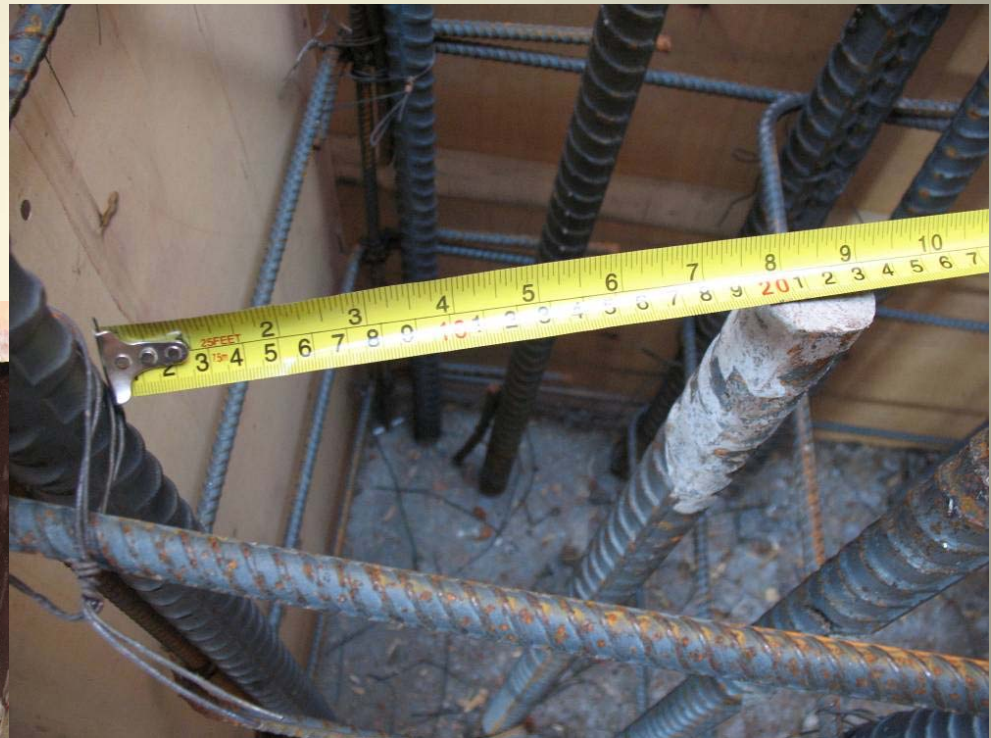
Special inspection and construction quality

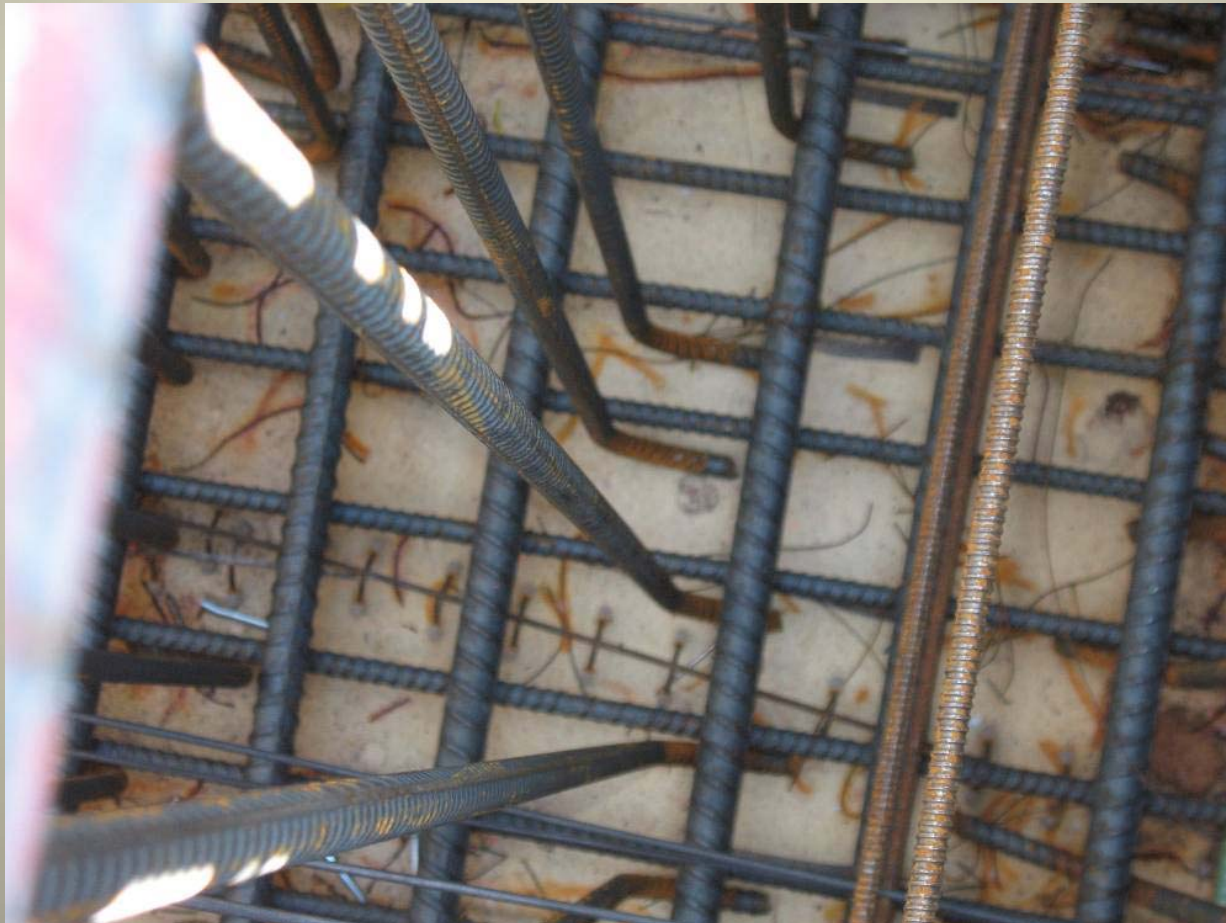
Special inspection and construction quality

- 67 sets of stirrups required per design
- 47 sets installed
- Shear capacity reduced by ~20%

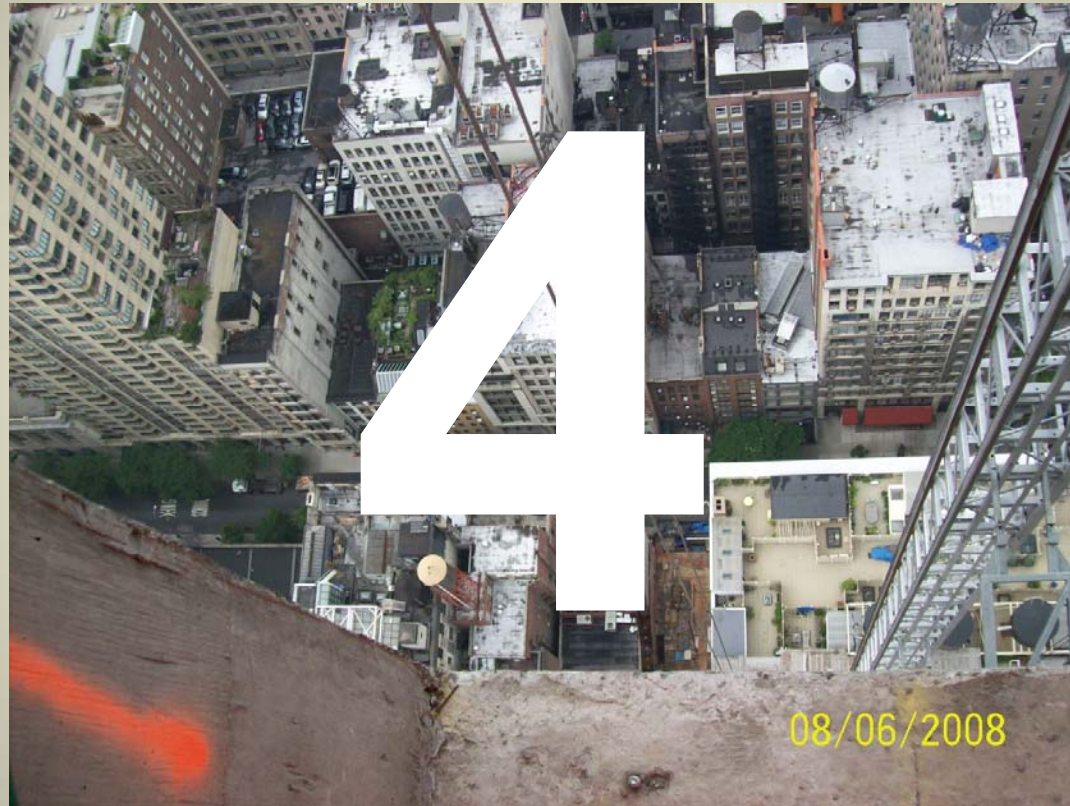
High-rise Concrete Worker Falls

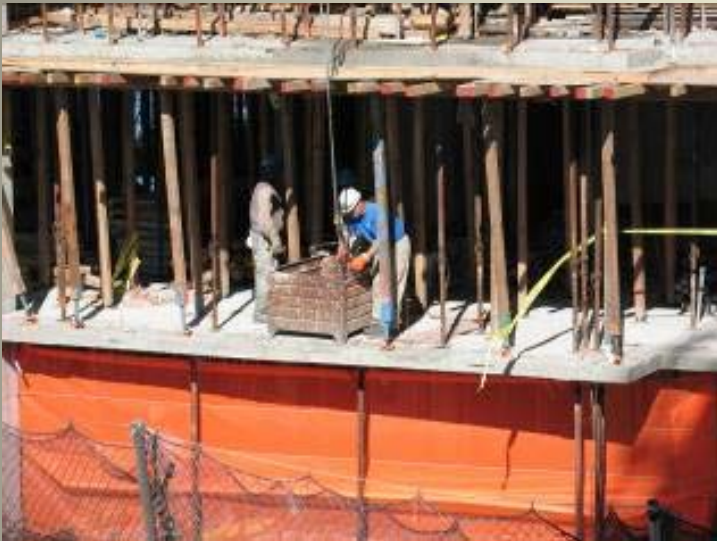
## Construction worker falls

- Observed defects
  - Insufficient leading edge protection
  - Insufficient interior opening protection
  - Improper or insufficient use of PFAS
  - Workers ignorant of tie-off requirements

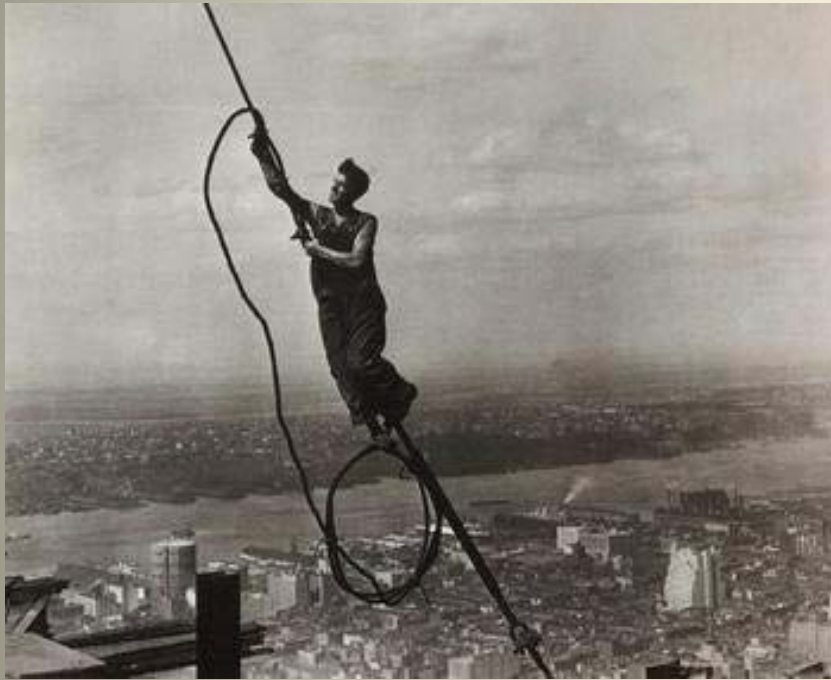
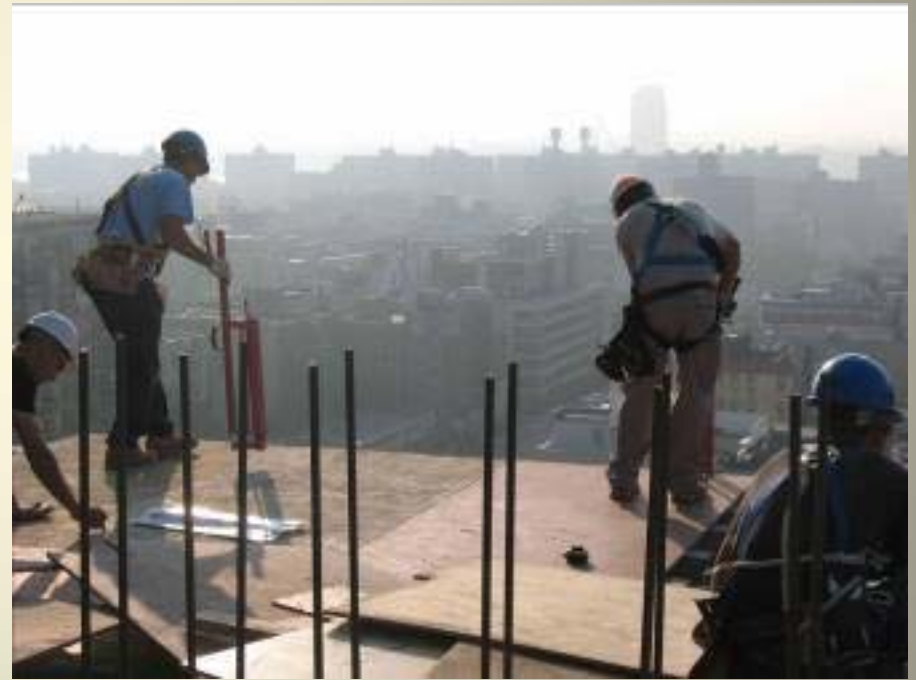
High-rise Concrete Worker Falls

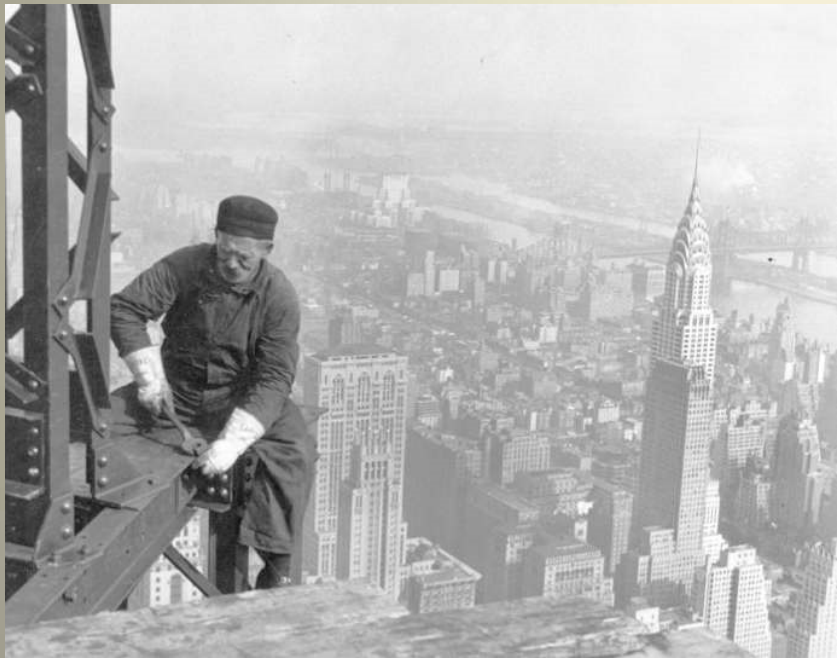
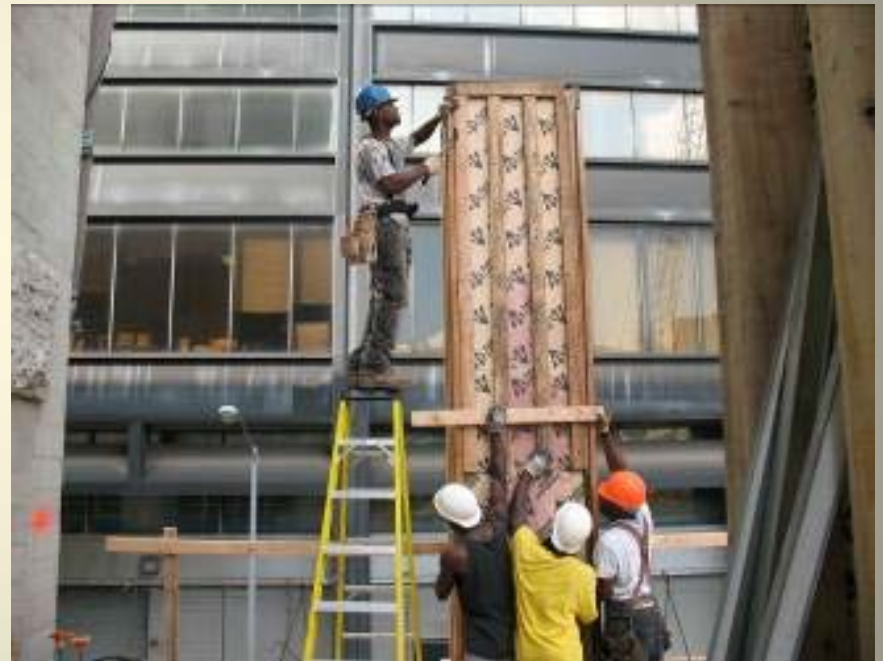
High-rise Concrete Worker Falls

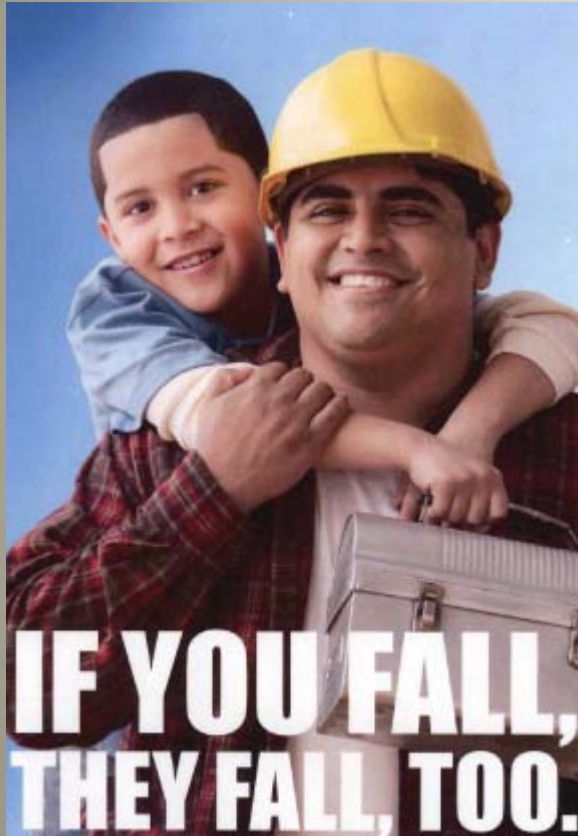
## Construction worker falls

- Reduce fall incidents
  - Site safety line of accountability:
    - Leads to owner (not to CM)
  - Non-compliant workers:
    - Contractor to document remedial actions taken
- Implement fall hazard awareness campaign
